Manhole Inspection Summary

Manhole # S15MM1023MH

Insp Date: **12/5/06 2:05 PM**

Location Address: **4555 LANIER AVE**

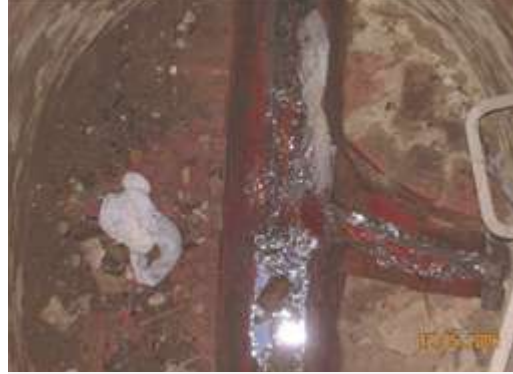
Top View

Barrel infiltration. Evidence of surcharge - Bench debris. Channel debris.

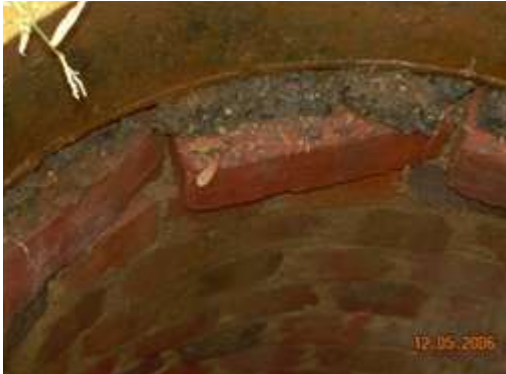
Defect

Frame Offset: **2** (in.) Condition: ☐ Sound ☐ Cracked ☒ **Leaks**

Condition: ☐ Sound ☐ Cracked ☐ Root Intrusion ☒ **Loose Brick** ☒ **Deteriorated**

Infiltration: ☐ None ☒ **Joint** ☐ Cracks ☒ **Mortar** ☐ Roots ☐ Wall

Frame leaks. Adjustment deterioration, loose brick, and infiltration.

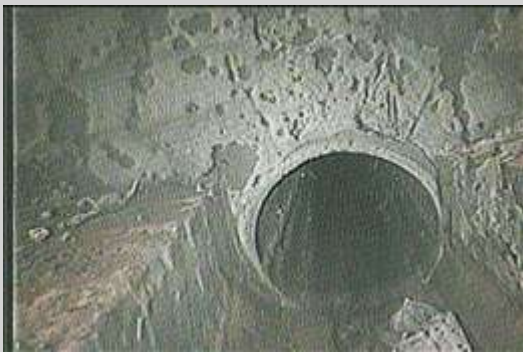
8 in. Circular Gravity Sewer Pipe Out @ 12 O'Clock

Deposits: ☐ None ☐ Mud ☐ Sludge ☐ Debris ☒ Grease

Silt Depth: **0** (in.) Deposits Extent: **Light**

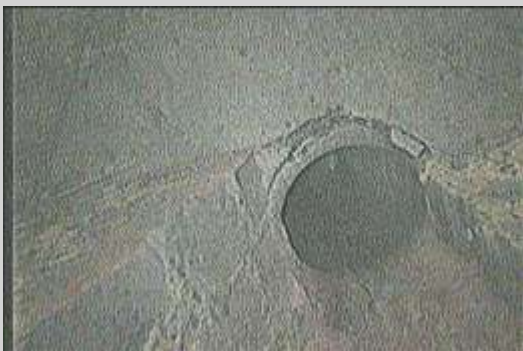
6 in. Circular Gravity Sewer Pipe In @ 3 O'Clock

Infiltration: **Evidence** Pipe Seal Cond: **Broken**
